**US Army Corps
of Engineers®**
Engineer Research and
Development Center

Innovative Coating System for Corrosion Prevention and Temperature Reduction in Heat Distribution Manholes

Final Report on Project FAR-11 for FY06

August 2009

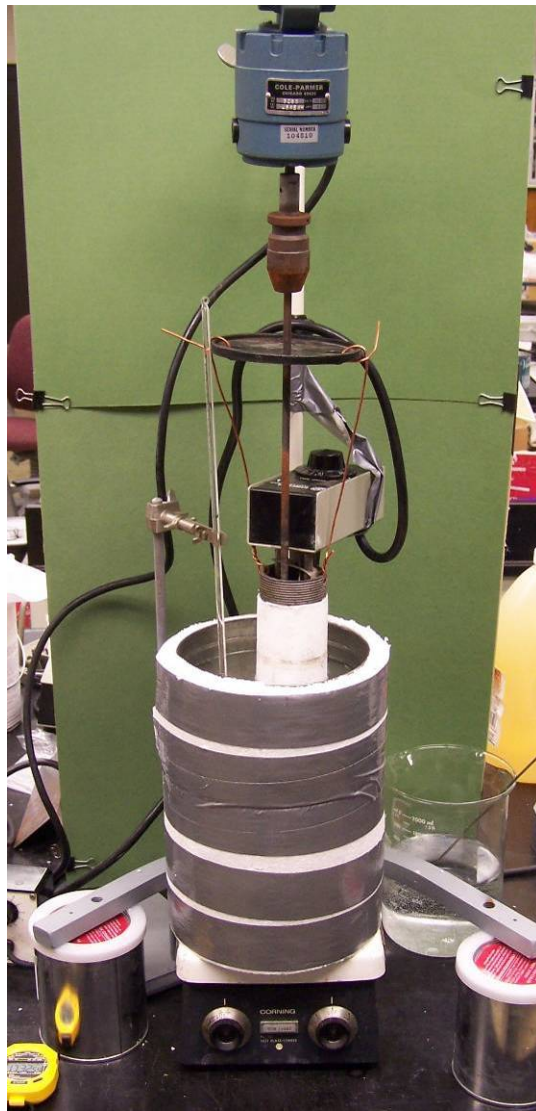
Test specimens consisted of common 2 in. diameter steel pipe sections. Each specimen was 12 in. long with one end welded closed. All specimens were abrasive blasted with aluminum oxide grit for a surface profile of 2.5 mils, as measured by ASTM D 4417 Method C. All specimens were primed with an epoxy zinc primer meeting MIL-DTL-24441 Formula 159. Primer thickness was measured to be 2.5 mils, using a Positector 6000 gage in accordance with ASTM D 1186. Experimental specimens were topcoated with Capstone TC Ceramic at thicknesses of 50 and 85 mils (ASTM D 1186). The topcoat dried a minimum of 2 weeks at laboratory conditions before initiating the tests.

Water in the pipe was heated with an immersion heater and maintained at a boil throughout the test. Small increments of water were added to the specimen pipe during the test to replace water that had evaporated. Water in the insulated container was agitated using the magnetic stirrer. Its initial temperature was approximately 24 °C (indoor ambient) and was monitored at 1 minute intervals by reading from the immersion thermometer. During the test, the thermometer was moved to different places in the insulated test bath, and was found to vary less than 2 °C between locations. Temperatures were recorded starting when the water in the pipe first reached a rolling boil, and observations were concluded when the temperature in the insulated container stopped rising and reached a constant level.

Figure 2.1. Test apparatus set up in lab.

The initial test cycle was performed on the pipe coated only with primer. This run was terminated early due to mechanical problems, and a duplicate run was performed to completion. Data for both runs are shown in Appendix C, Table 2. It should be noted that the first recorded temperature of the water on these runs is 68 °C because it took a long time for the heater to bring the water in the pipe to a rolling boil. The initial water temperature in tests using pipe coated with 50 mils of ceramic coating is much lower because the water in the pipe came to a boil quickly.

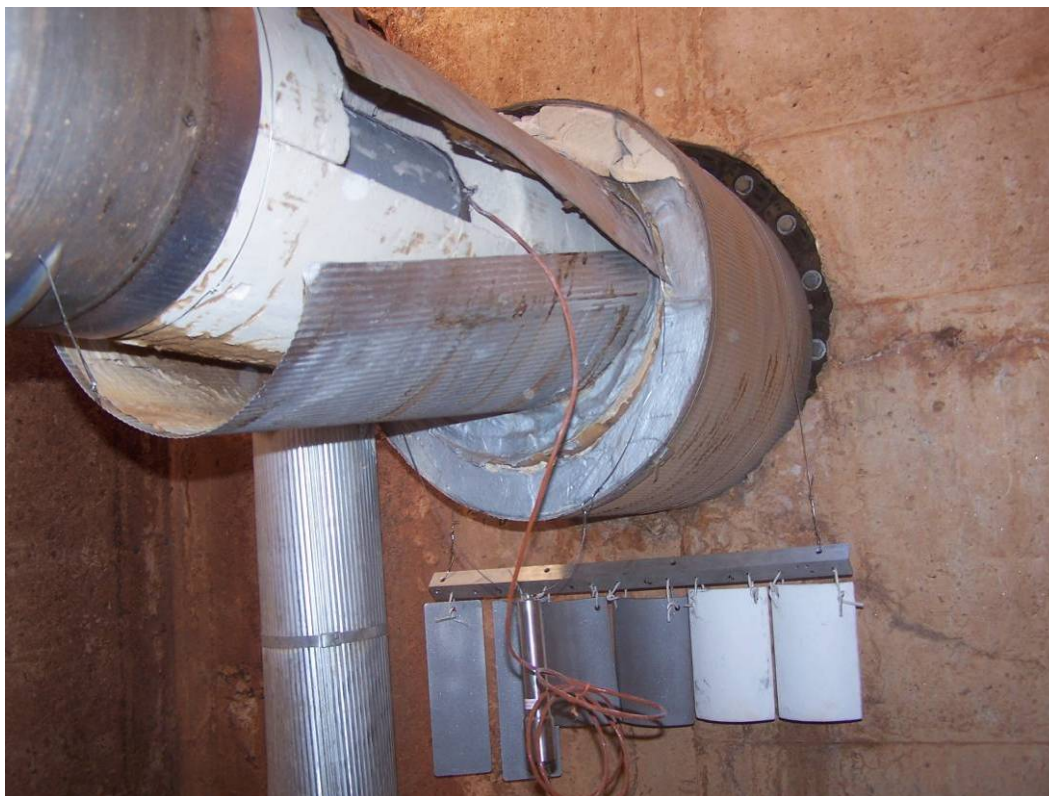
At the time the panels were installed, data loggers were placed in both pits to record the temperature both inside and outside the jacketing (Figure 2.2). The devices included both an external temperature probe, attached to the data logger by a wire, and an internal temperature sensor in the body of the data logger. The external temperature probe was installed inside the jacketing in the control pit, under the insulation and in direct contact with the carrier pipe. The data logger (with its internal temperature sensor) was hung close to the pit wall, near the metrics coupons. The external probe in pit 3 was positioned on the surface of the coating, under the insulation. The temperature data were recorded for use in the project's return-on-investment (ROI) study.

Figure 2.2. Metrics setup in control pit, showing panels hung near manhole wall, data logger, probe lead, and control coupon mounted in insulation cutout.

At the time the coupons and data loggers were installed in the two pits, the exposed ceramic-filled topcoat in pit 3 was light tan in color and showed no flexibility. Technically, the film was intact, but most of it was no longer adhered to the primer. Impacts from opening the insulation had cracked the topcoat film, and in some places it fell away from vertical surfaces. This observation clearly indicated a greater level of topcoat deterioration than had been observed in the laboratory oven exposure study (see Section 2.2.2), which was conducted at 360 °F. At this point, the temperature was measured in pit 3 and found to exceed 380 °F. The preliminary hypothesis by the researchers was that the topcoat had failed due to actual operating temperatures in excess of what had been estimated by the system operator.

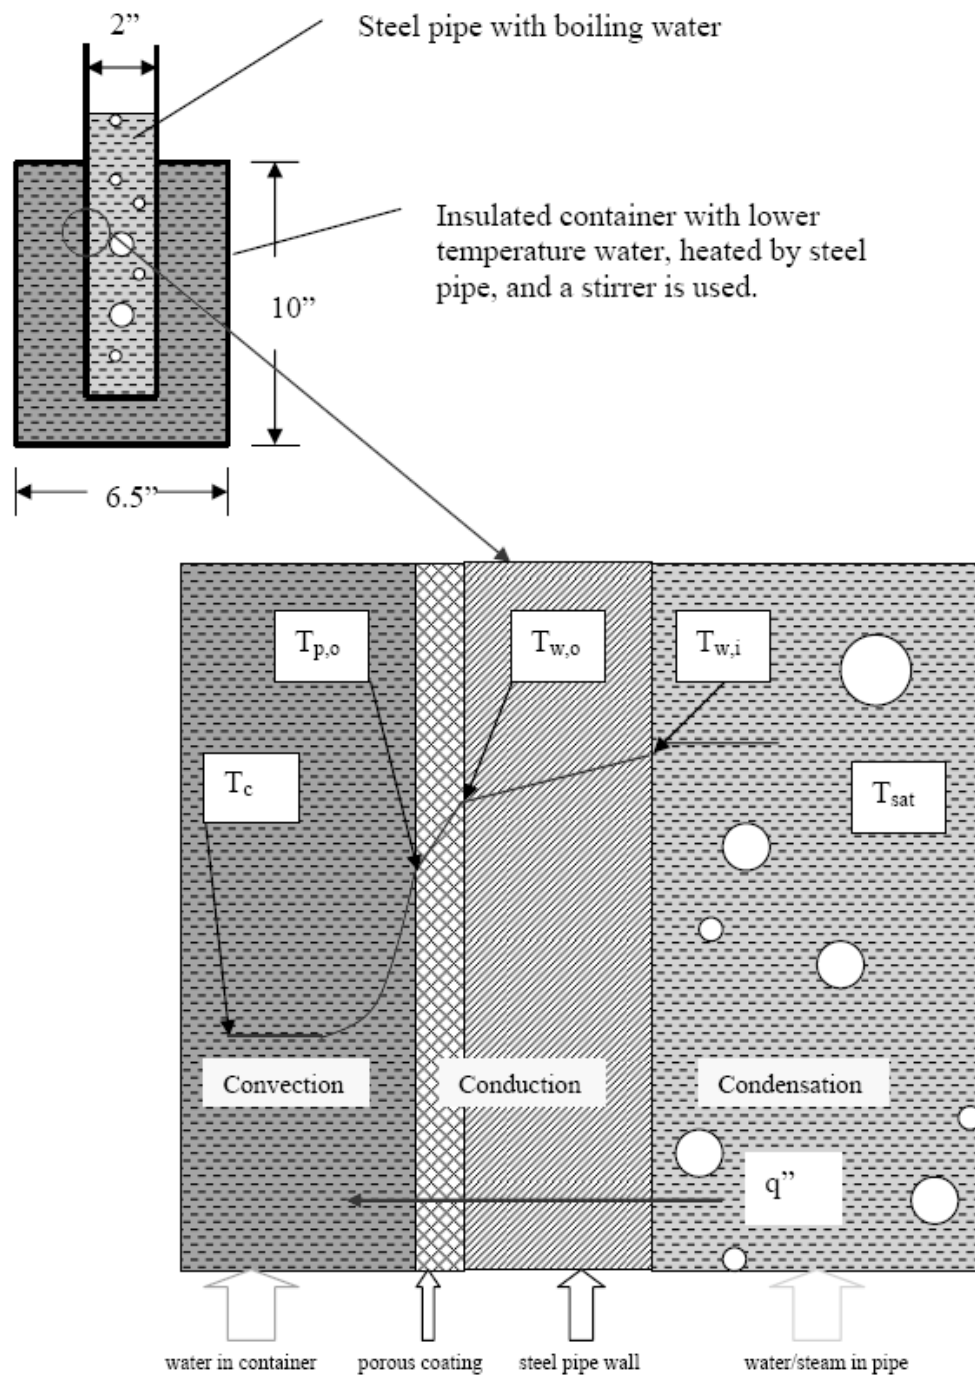
Considering that the water temperature inside the pipe is constant at the saturation temperature, and that the water temperature in the insulated container is relatively uniform, and then it can be assumed that the heat flux is uniformly distributed on the pipe surface. That means, the q'' is not a function of position, but only a function of time, t .

Figure 1. Schematic of the experimental test facility

In any time interval between minute N and minute N+1, all energy (heat) passing through the pipe interface heats the water inside the insulated container. So,

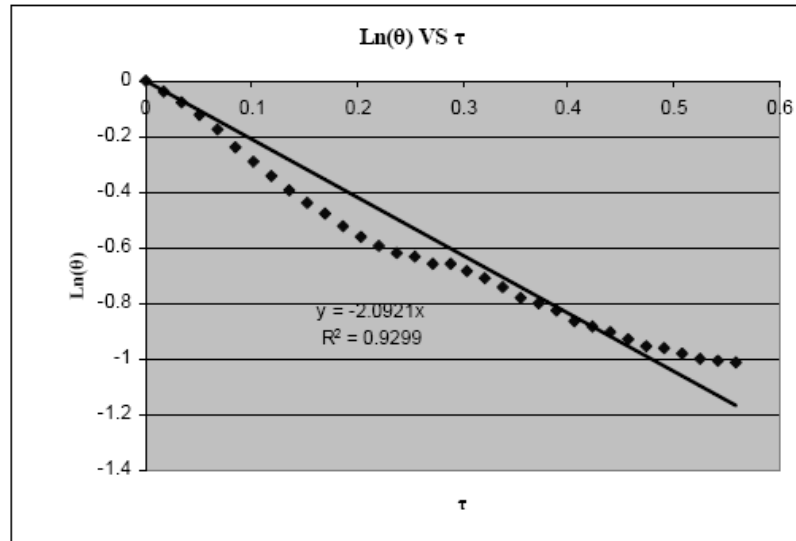
Figure 2. Linear curve fitting for no porous deposition case

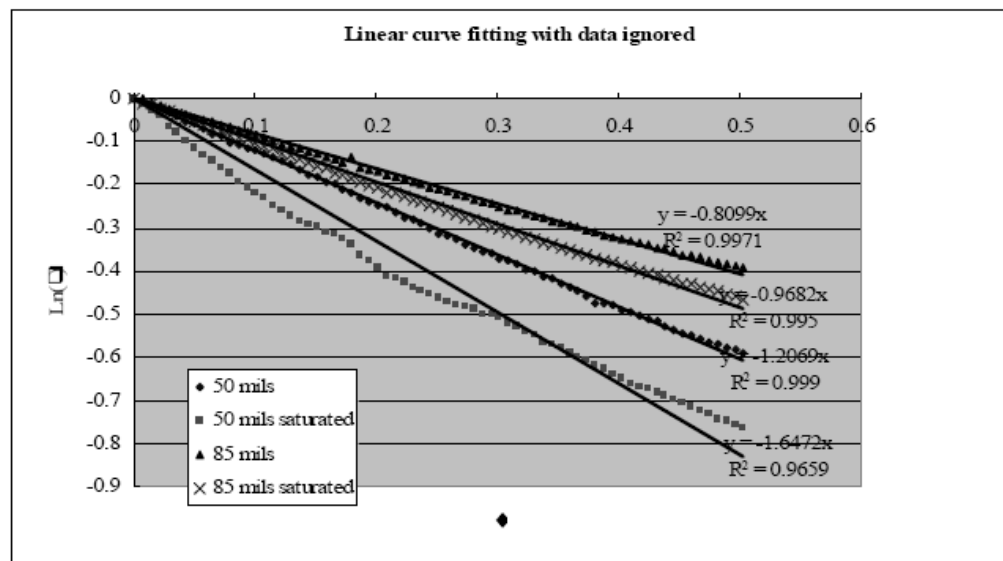
The four sets of experimental data are plotted in Figure 2. To reduce the error, parts of the data are ignored. As shown in Figure 3, the x-axis represents the non-dimensional time, τ , and the y-axis represents the logarithm of non-dimensional temperature, $\ln(\theta)$. The values of slop, C_1 , and goodness of fit, R^2 , for these four sets of data, and corresponding calculated thermal conductivity of each porous coating are listed in Table 1.

Figure 3. Linear curve fitting for experimental data with data nearing the end of the experiment being ignored

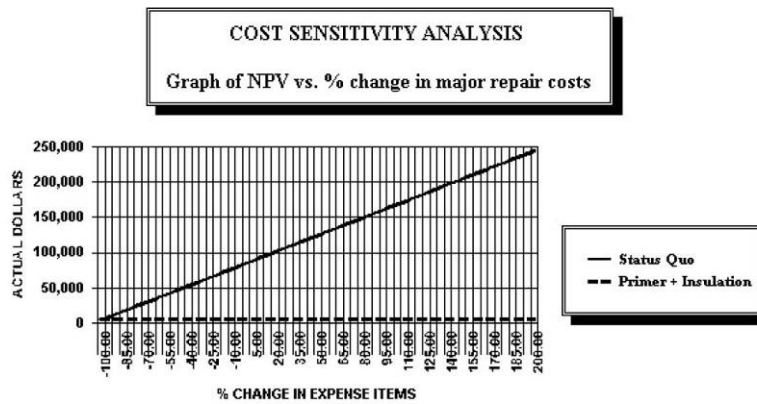
Alternative's rankings may change when some of the assumptions in the analysis change. To test the robustness of the above ranking a test of the sensitivity of the analysis to changes in the estimated savings was performed. The analysis showed that the ranking of the alternatives was sensitive to changes in the cost of the major repair of the Status Quo alternative. For the Status Quo alternative to become the least cost alternative, the cost of the major repair has to be reduced by 99.3%. In other word, the cost of replacing 500 feet of supply and return buried pipe has to be less than \$1,070, well below ongoing rates. Figure 3 below, shows the NPV of each alternative against percentage changes in the cost of major repairs.

Figure 3: Pipe Replacement Cost Sensitivity Analysis
